# COMMISSION OF INQUIRY HINTON TRAIN COLLISION

REPORT OF THE COMMISSIONER  
THE HONOURABLE MR. JUSTICE RENÉ P. FOISY  
DECEMBER, 1986

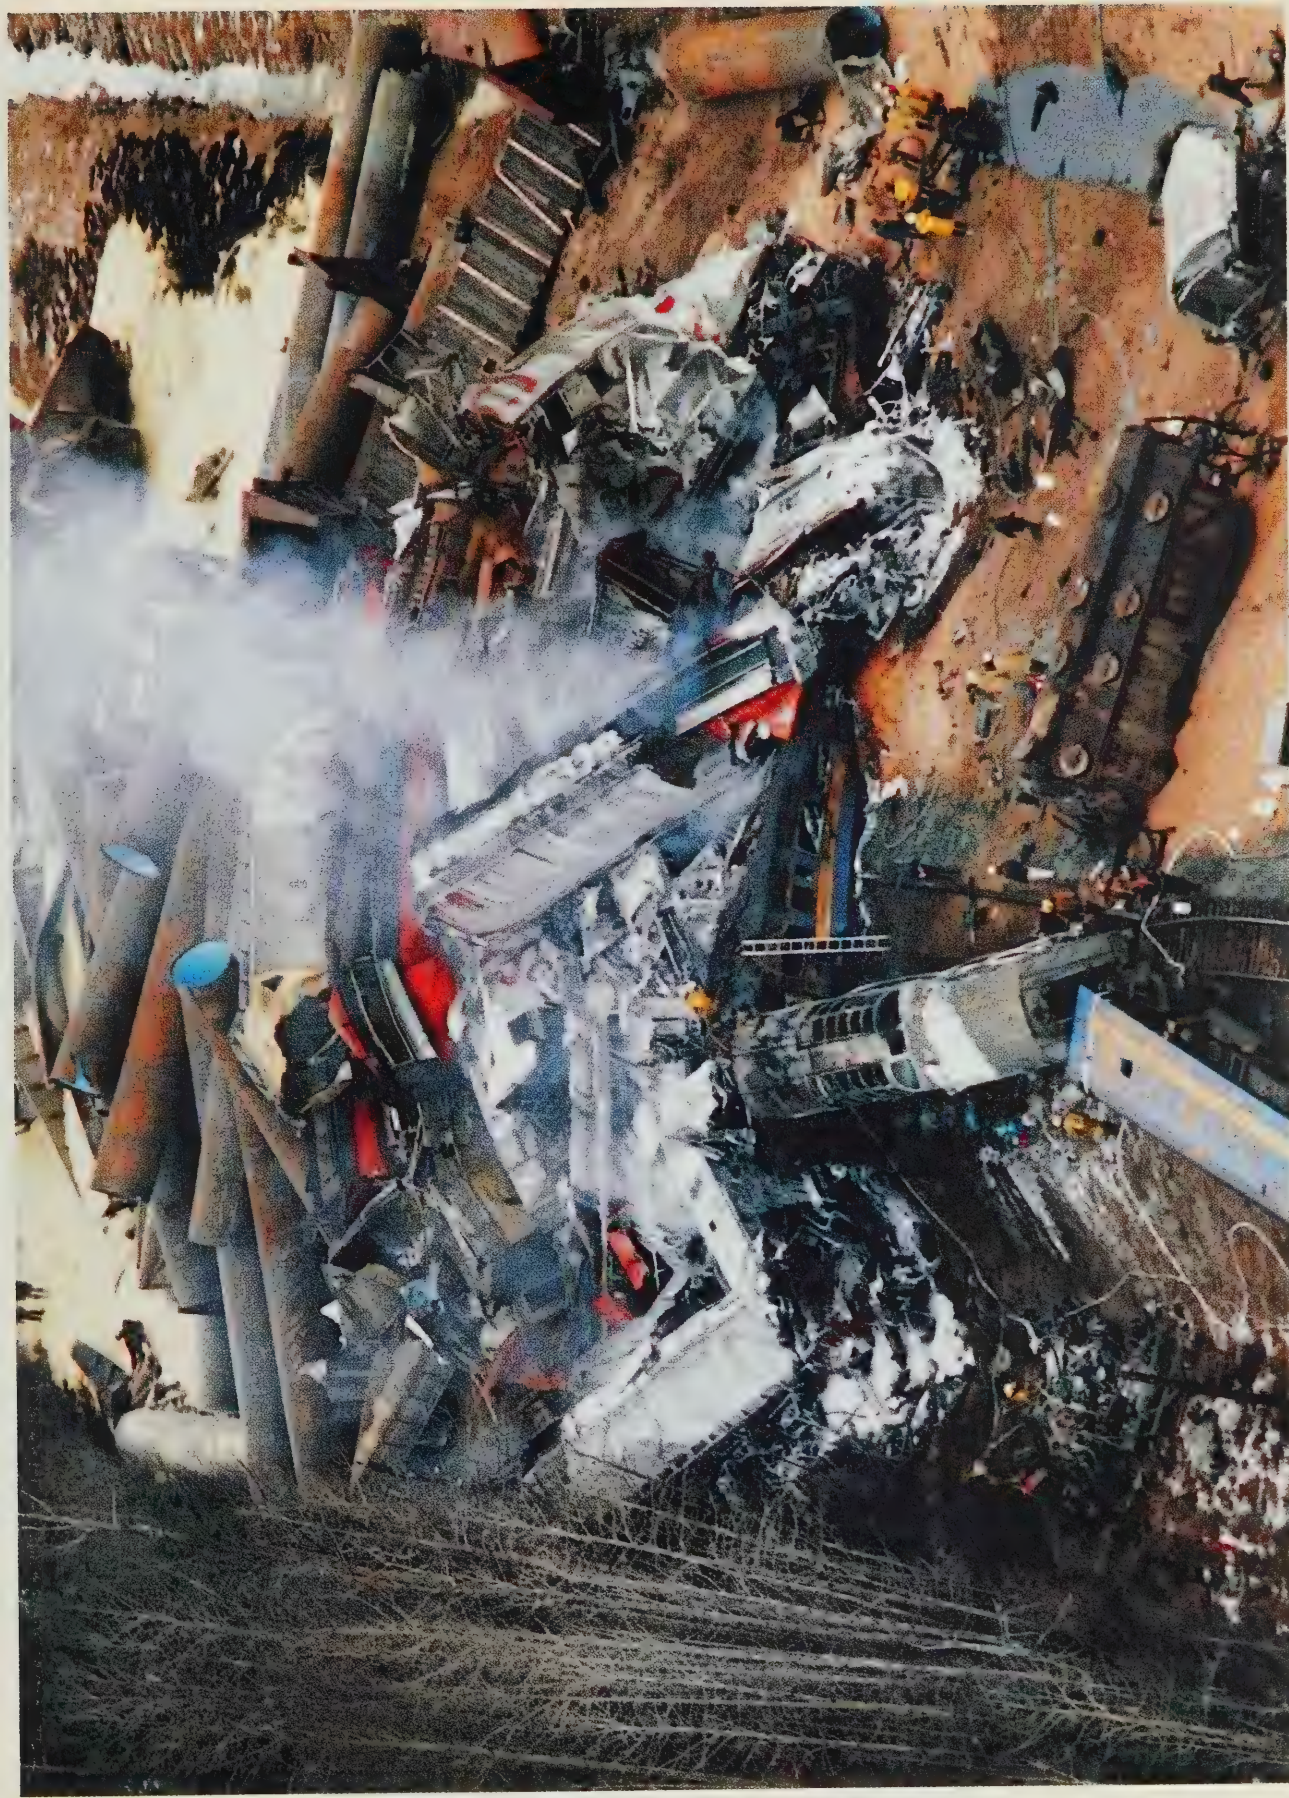
Photo 1: Collision Site Looking East. Credit: The Edmonton Sun.

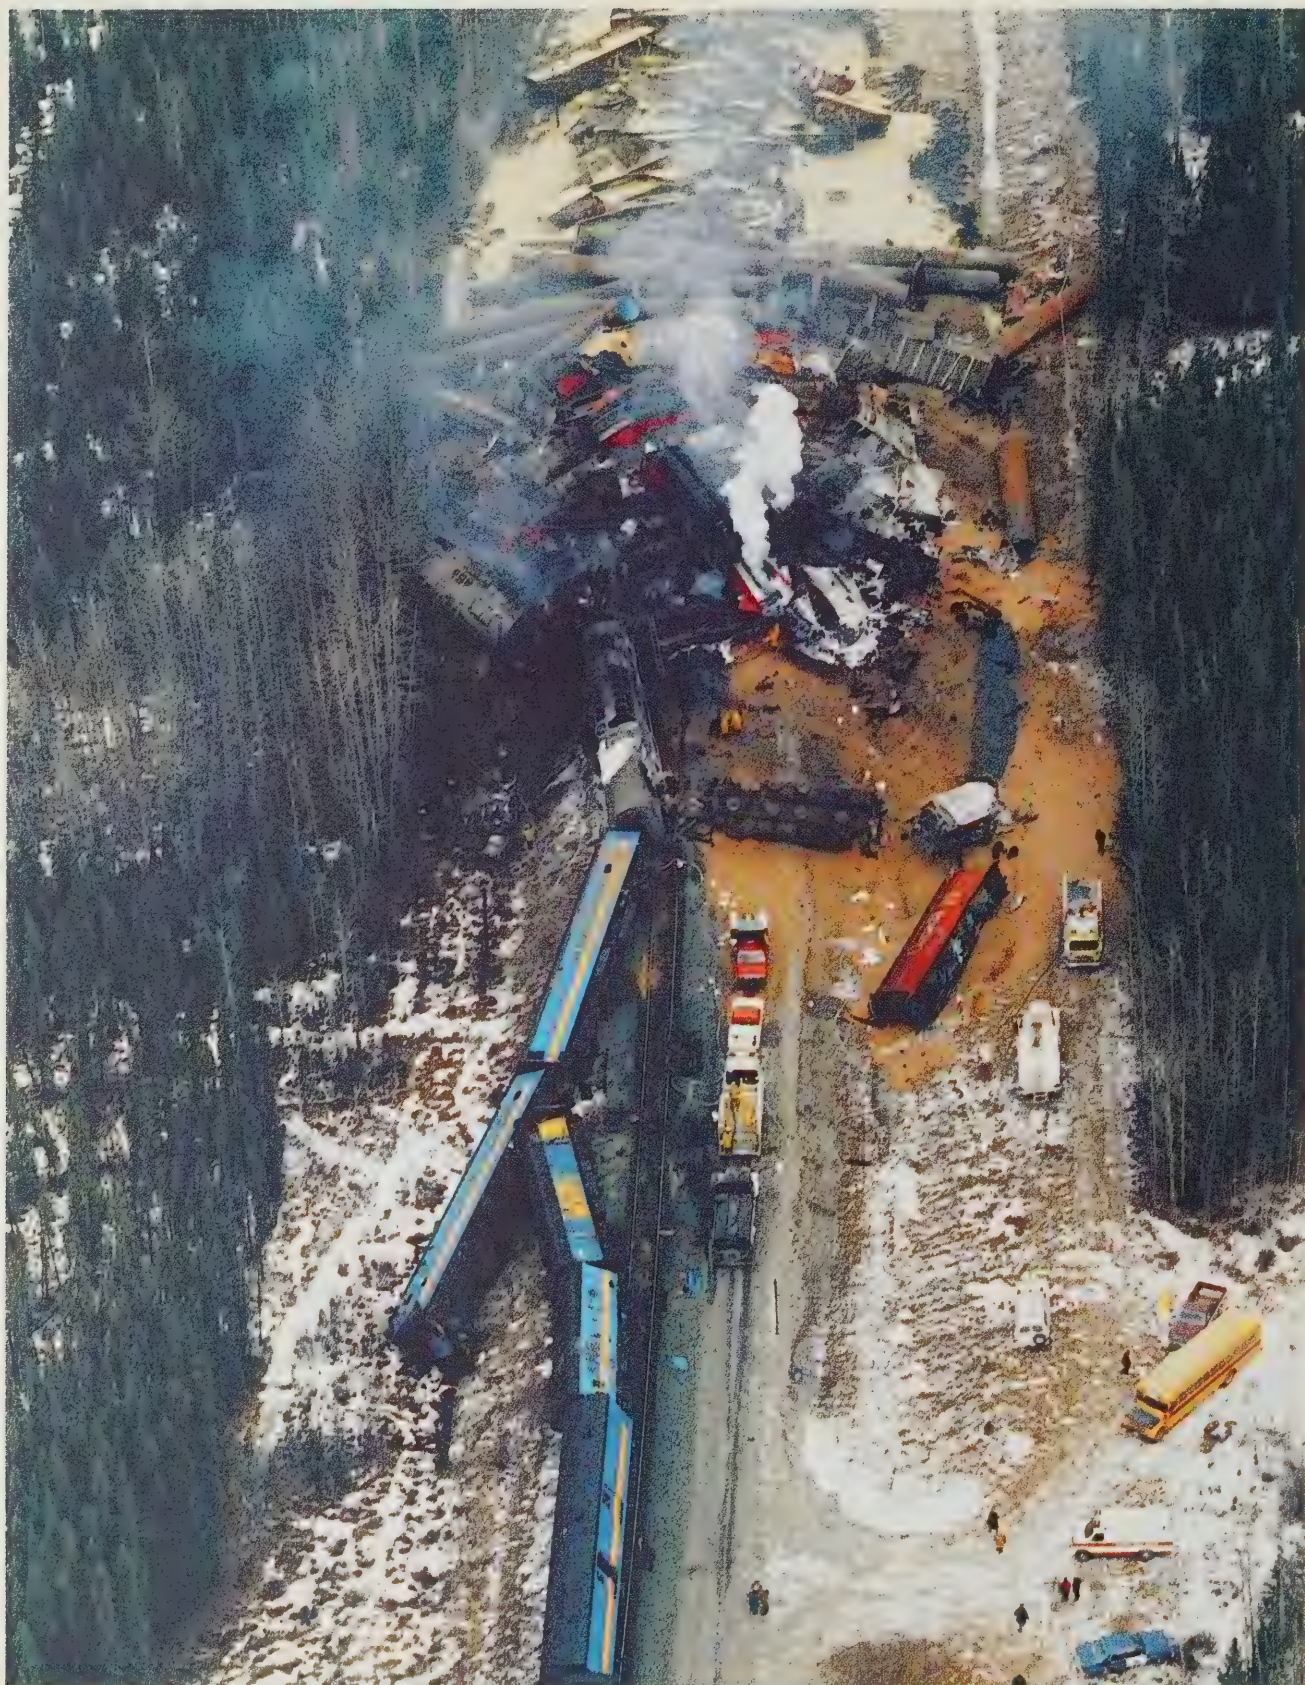
Photo II: Collision Site Looking East. Credit: Jim Cochrane, The Edmonton Journal.

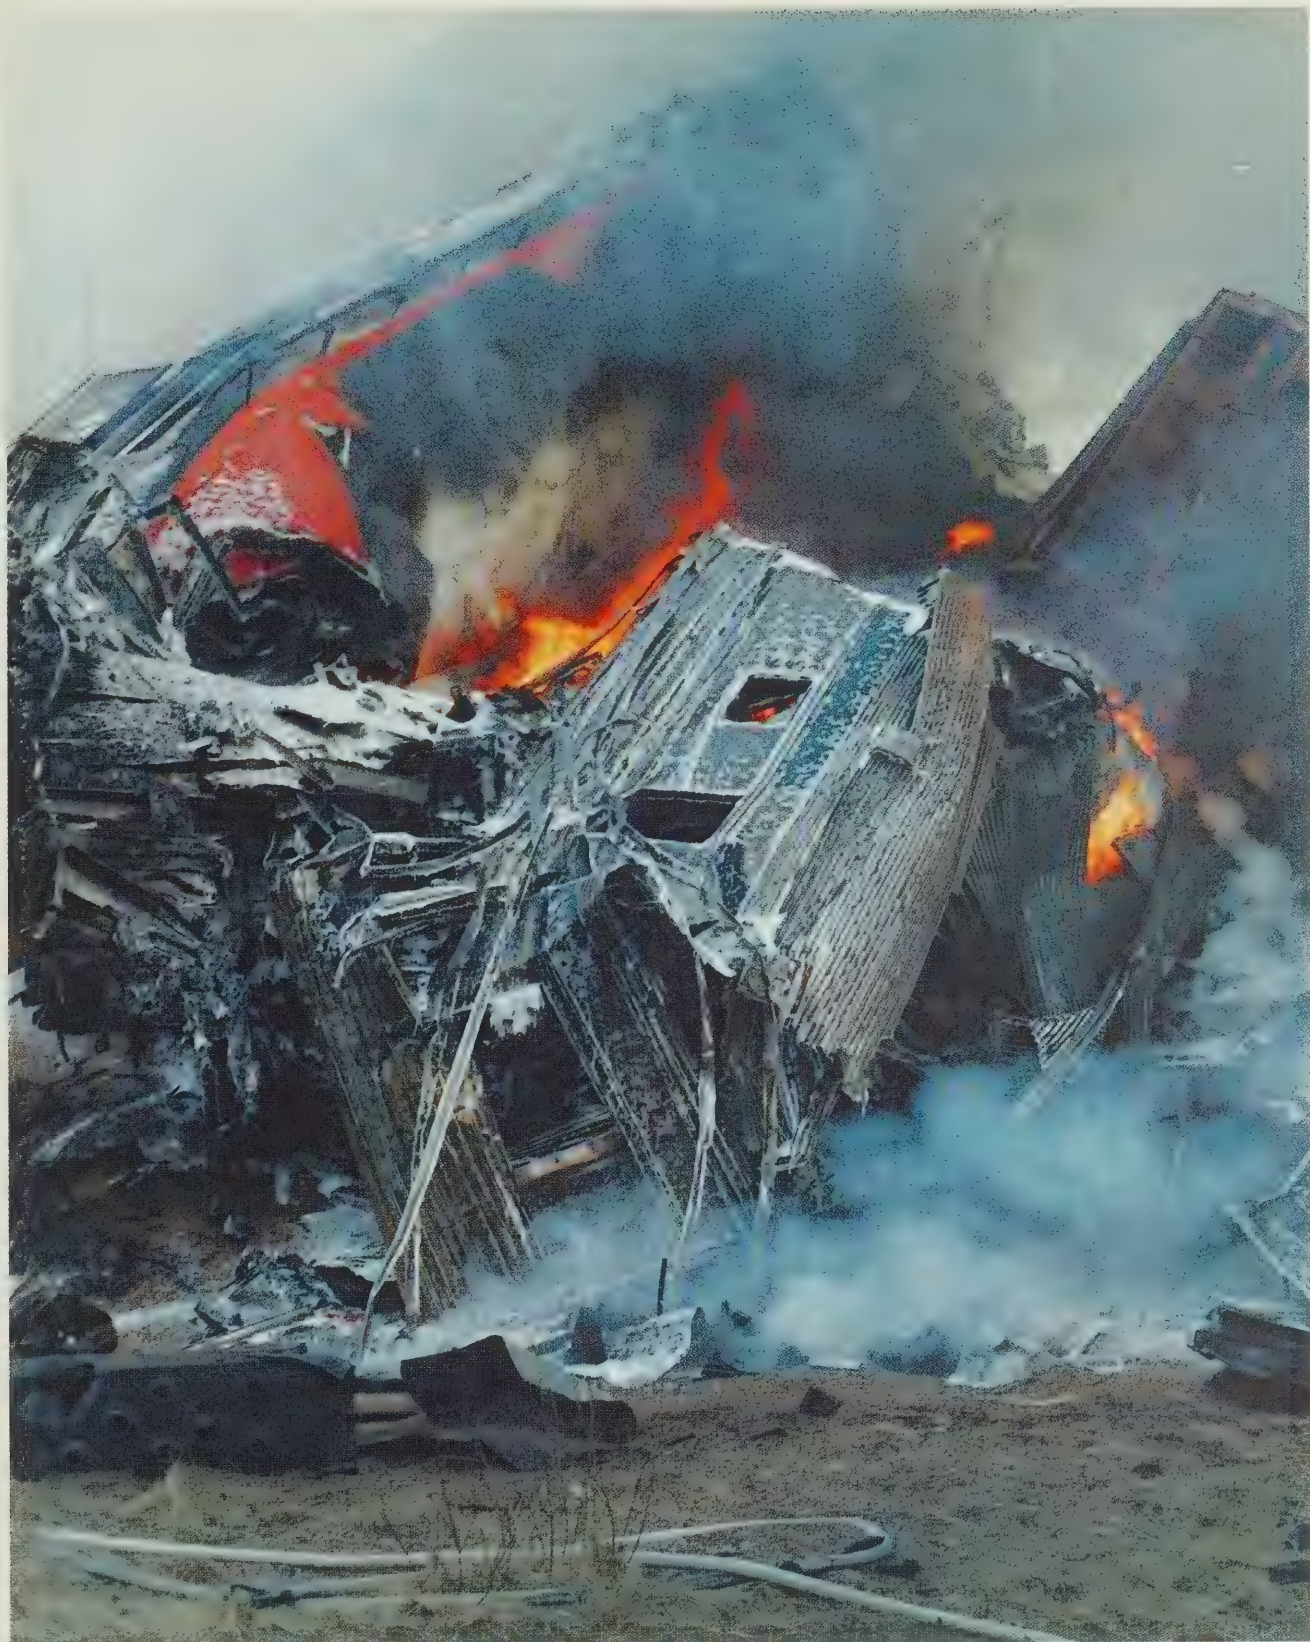
Photo III: Ground Level View of the Wreckage.

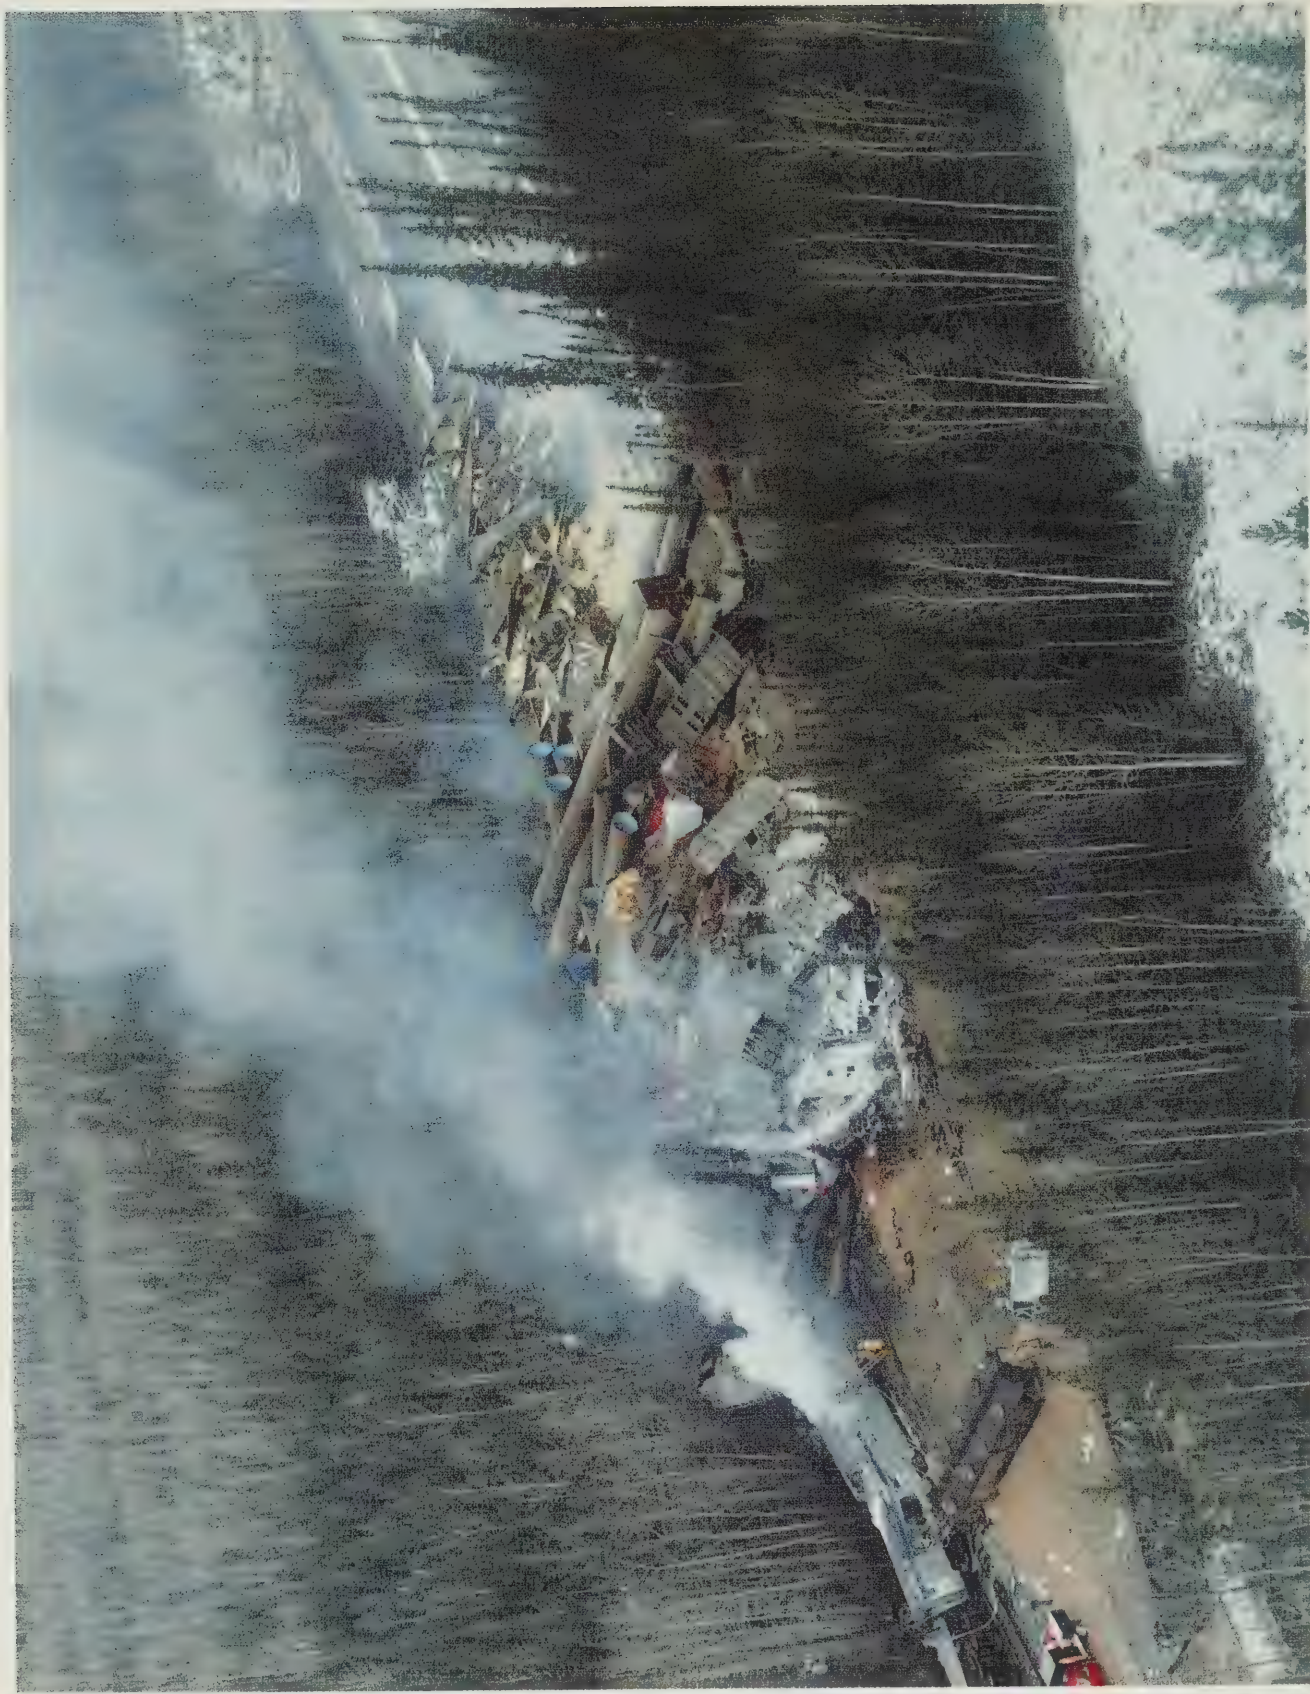
Photo IV: Collision Site Looking North.

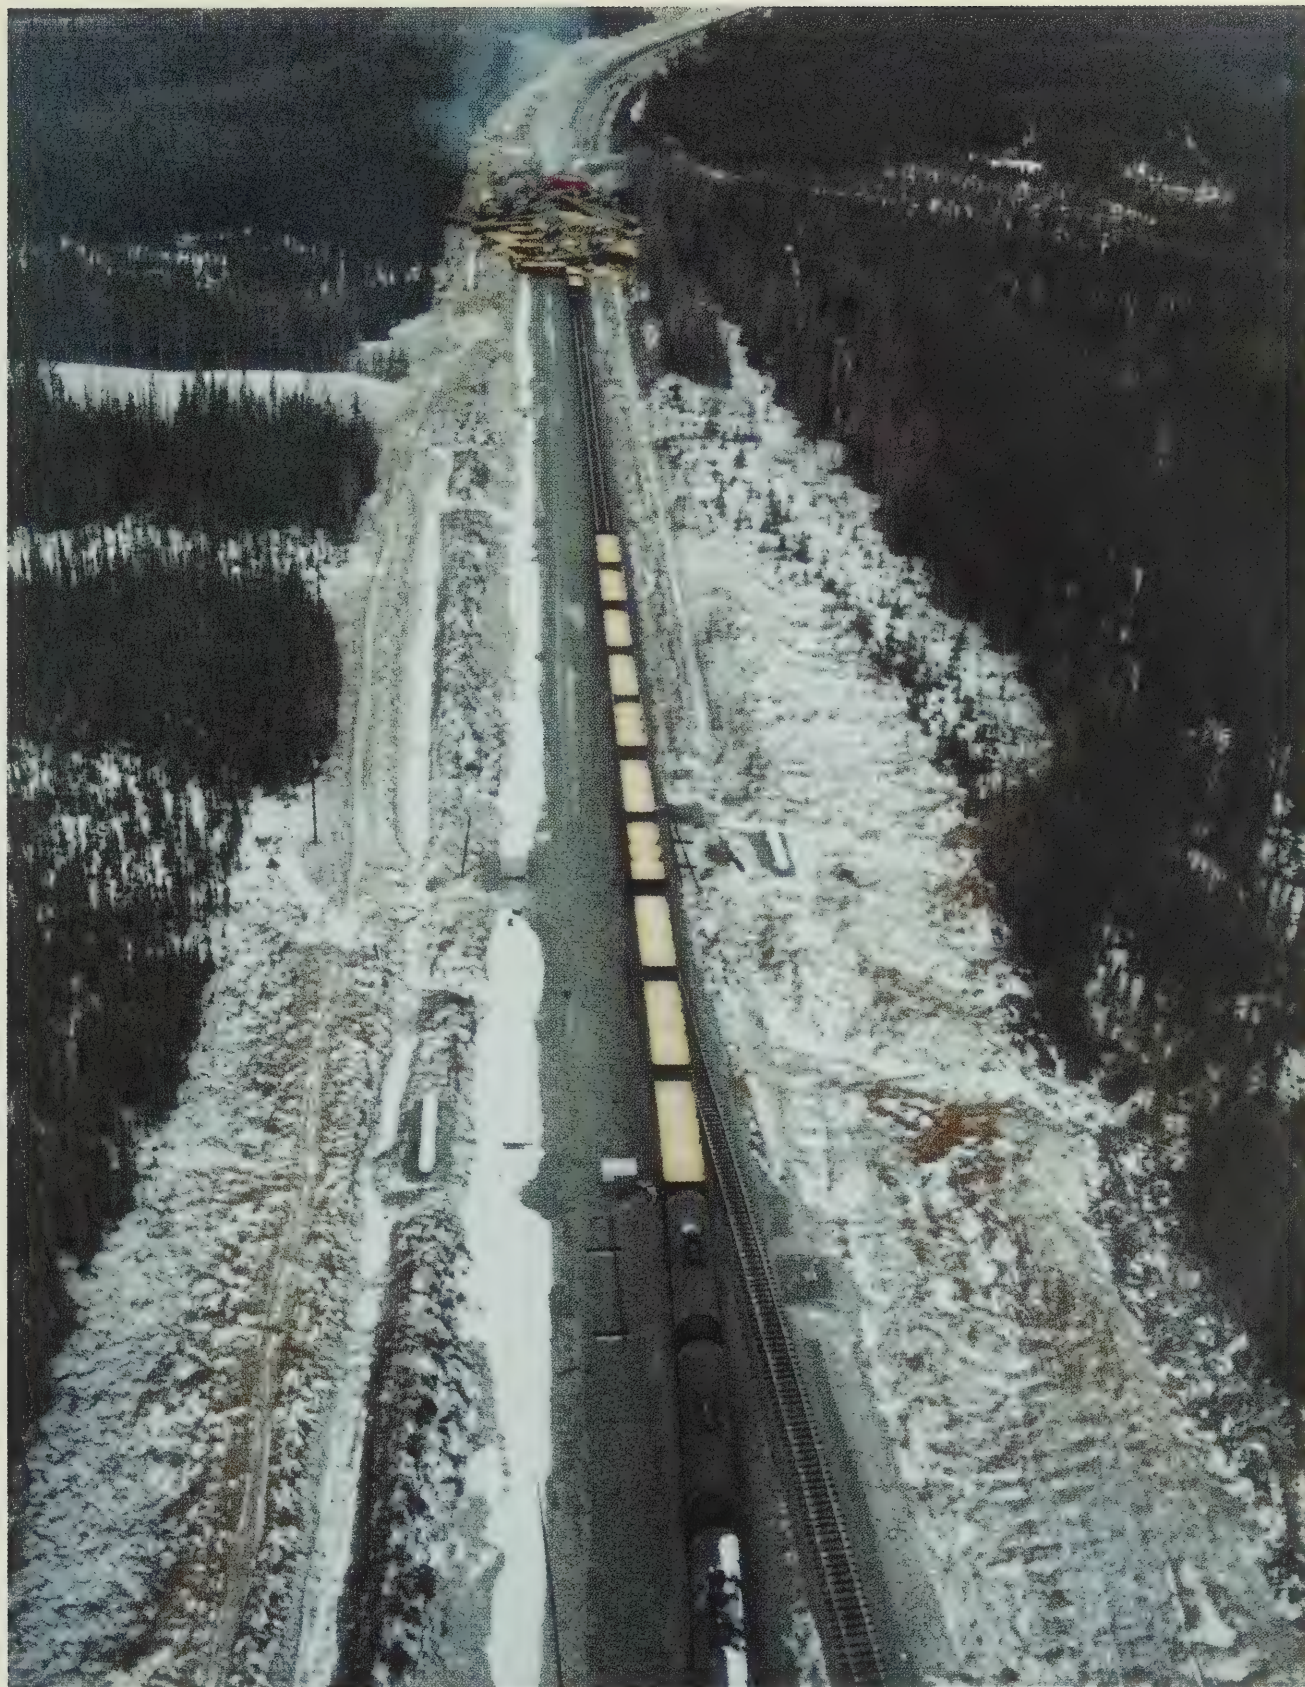
Photo V: View of Collision Site Looking West and Showing Section of Main Line Double Track in Foreground.

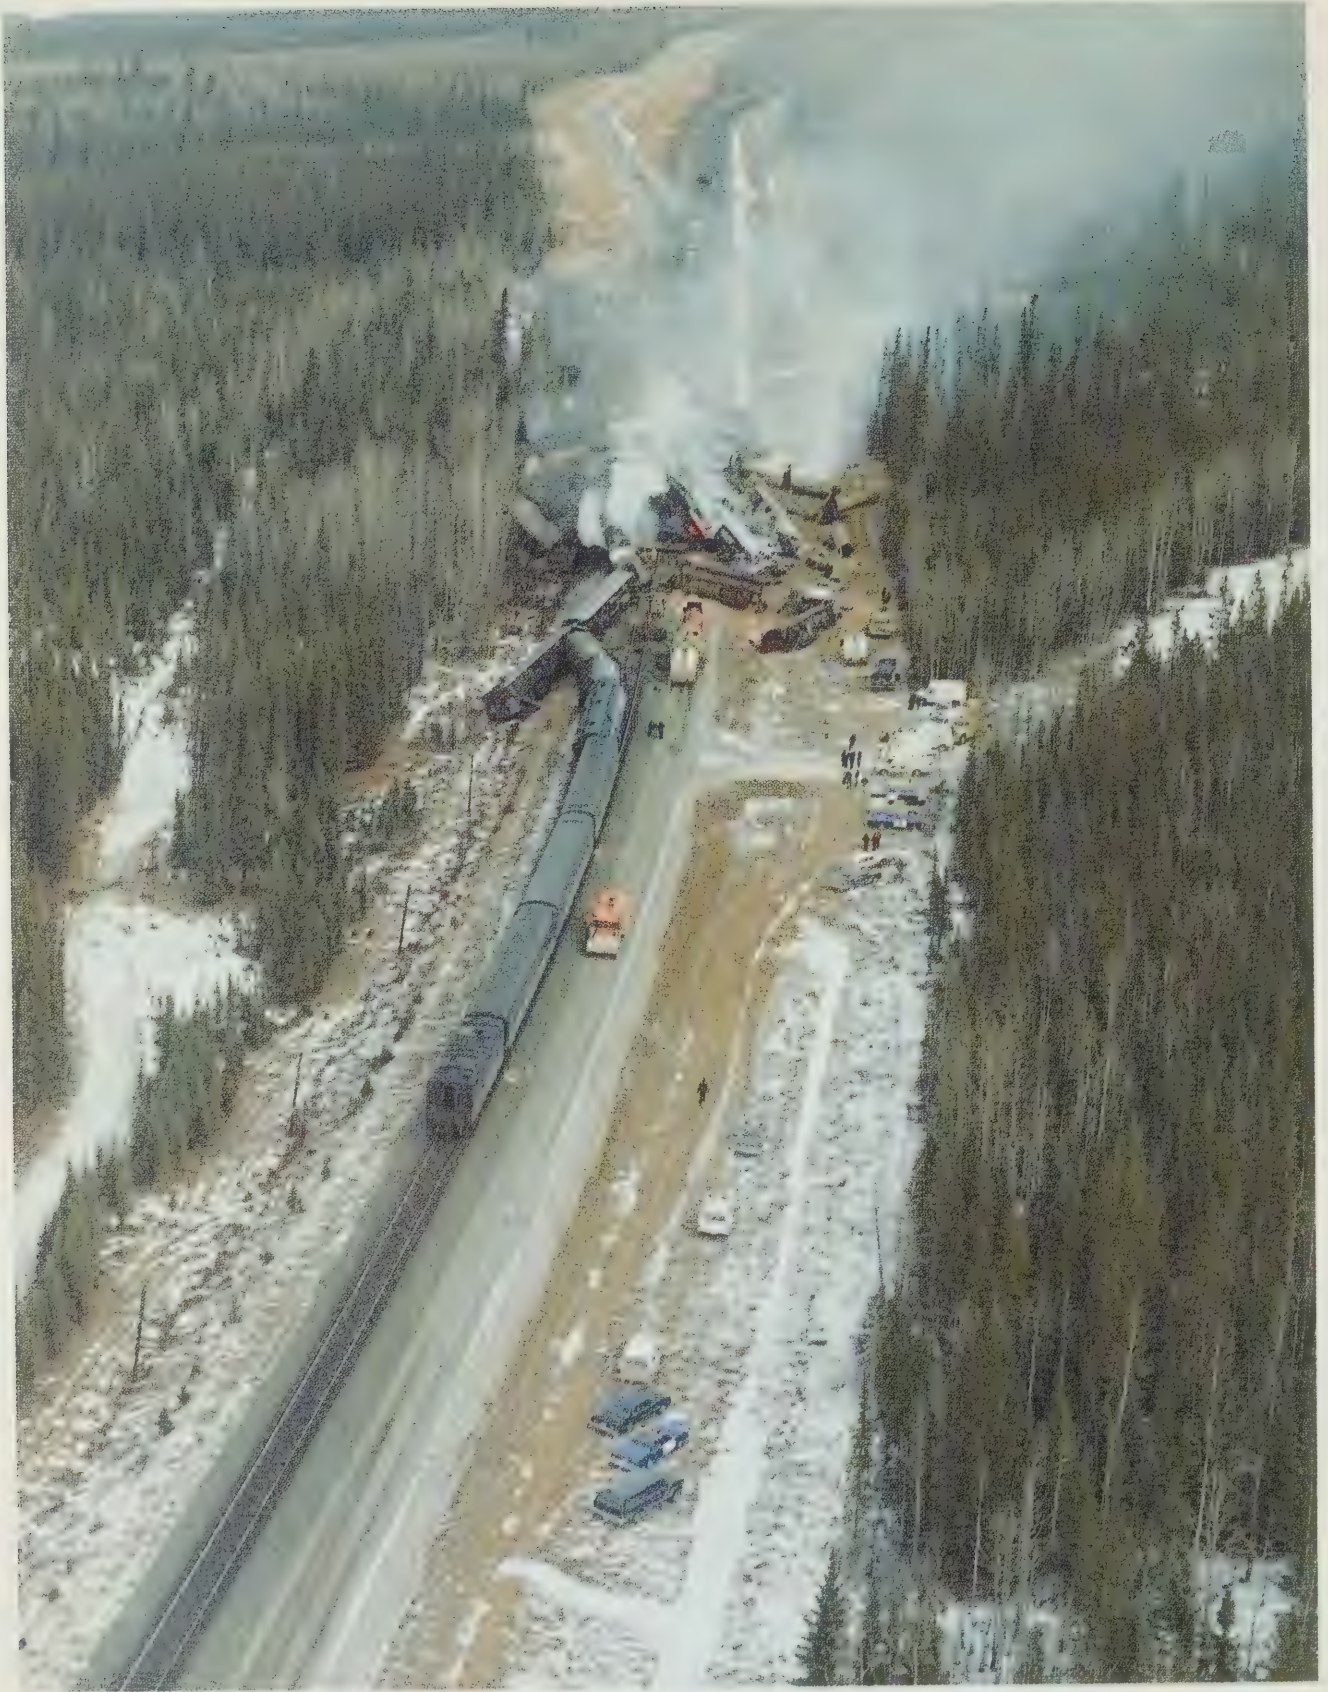
Photo VI: Collision Site Viewed Looking East and Showing Section of Main Line Double Track and Spur Line to the North.

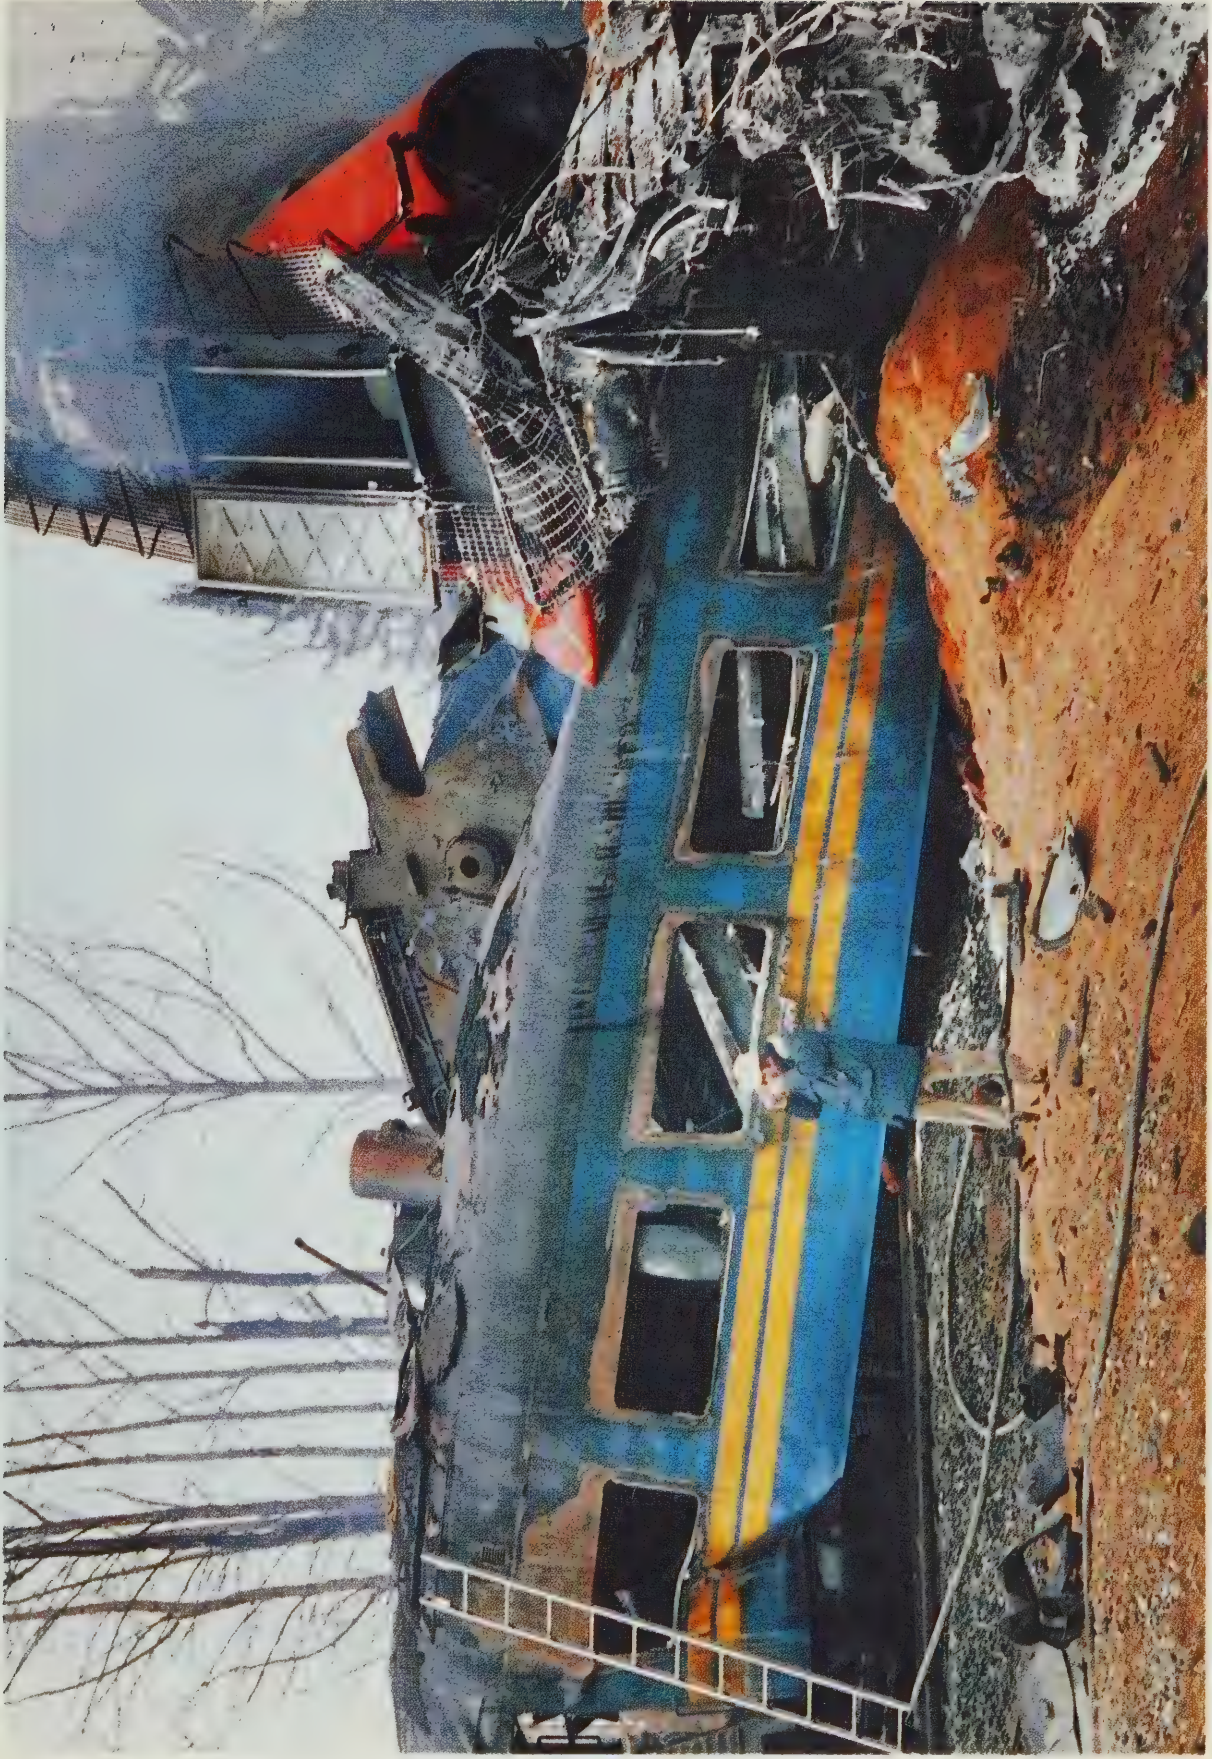
Photo VII: Via Passenger Car. Credit: The Edmonton Sun.

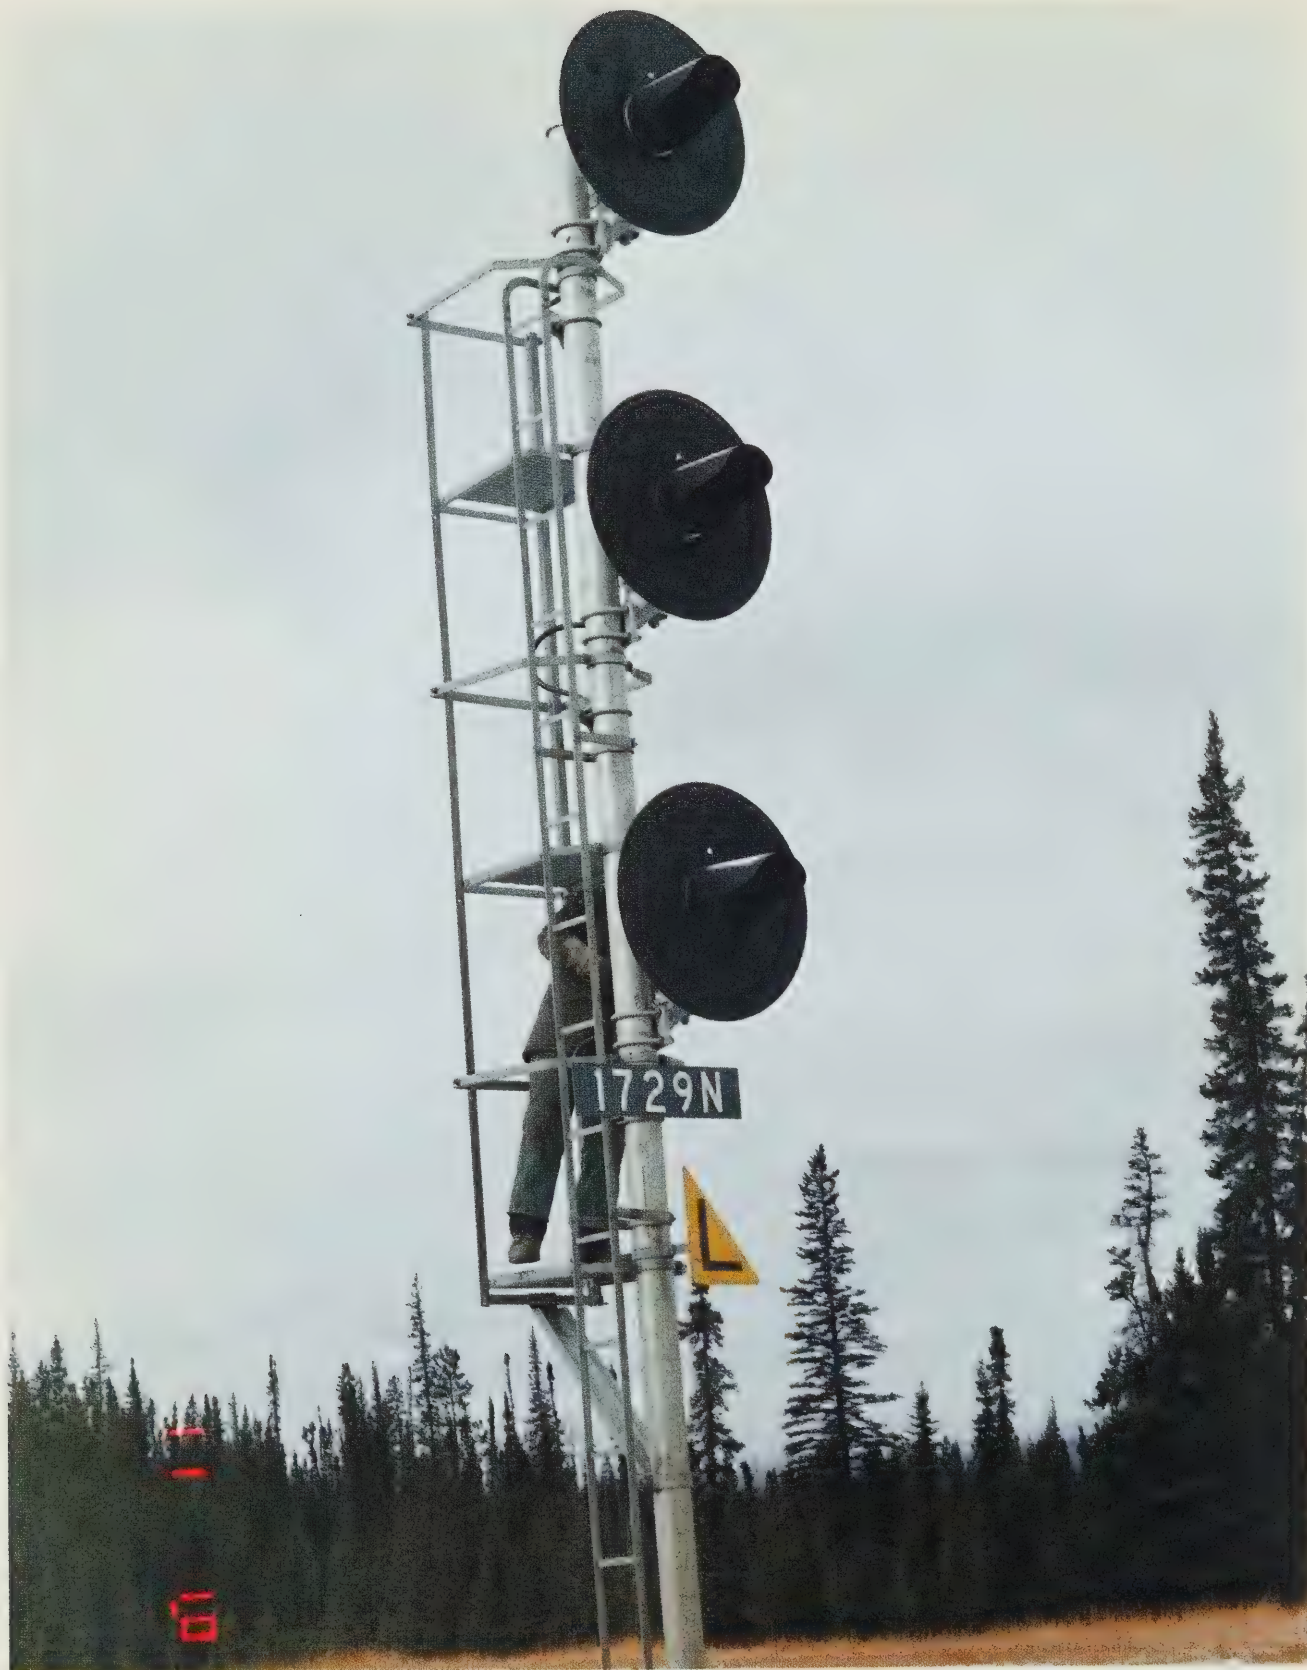
Photo VIII:

Signal 1729 N.
